Dantherm®

Water damage repair with a CDT dehumidifier

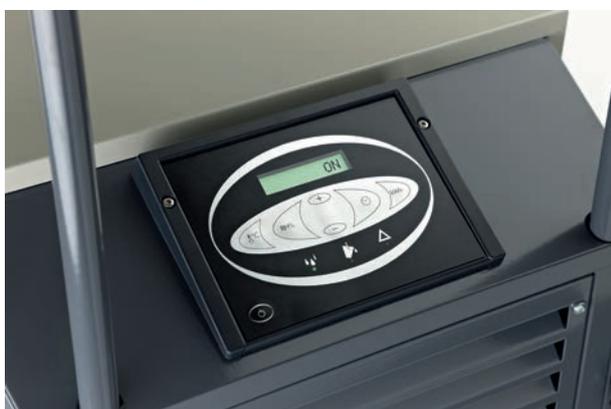
Digital display with integrated humidity control, energy counter, service status and easy fault finding allows optimal dehumidification.

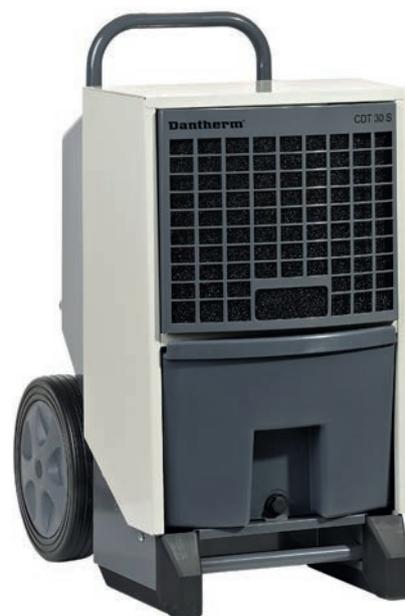
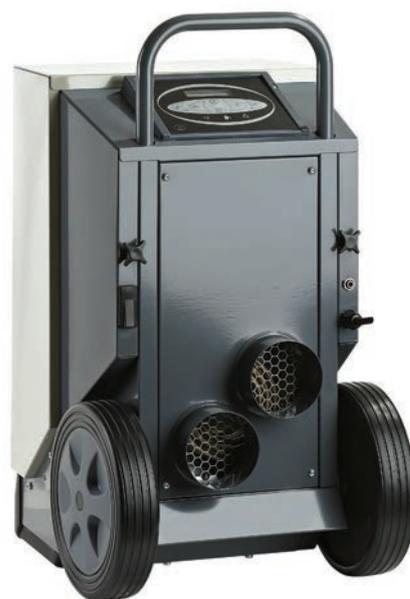
CDT 30 S

The CDT dehumidifiers work in accordance with the condensation principle. A fan draws in humid air and carries it through an evaporator. The air is cooled well below its dew point. The water condenses on the cold surface of the evaporator and drips into a water container or is led directly to a drain. The CDT-S models are equipped with a heating element that speeds up the drying process.

The CDT dehumidifiers are ideal for damage control and building drying. They are fitted with adjustable handles and big rubber wheels and are therefore easily moved from one room to the next.

In the case described above, the flooding was caused by burst pipes in the utility and living room. Therefore all flooring had to be removed in order to replace the pipes. Two Dantherm mobile dehumidifiers, CDT 30 S, had to be installed to get enough dehumidification capacity to dry out the room.

"In the living room only the wooden flooring had to be removed allowing the concrete to be dried out", says Bent Sønderberg, Skadeservice Danmark in Hinnerup. "We decided to spread out a barrier layer and dry-out the area underneath it. By doing it this way we managed to reduce the moisture content and get the maximum efficiency out of the CDT 30 S."
